Examination of a Glass Sample Reported from Cottage Pie

Work performed by Campden BRI (Chipping Campden) Limited
Report number: MI/REP/170532-00526/1 ♦ Issue date: 31st May 2017

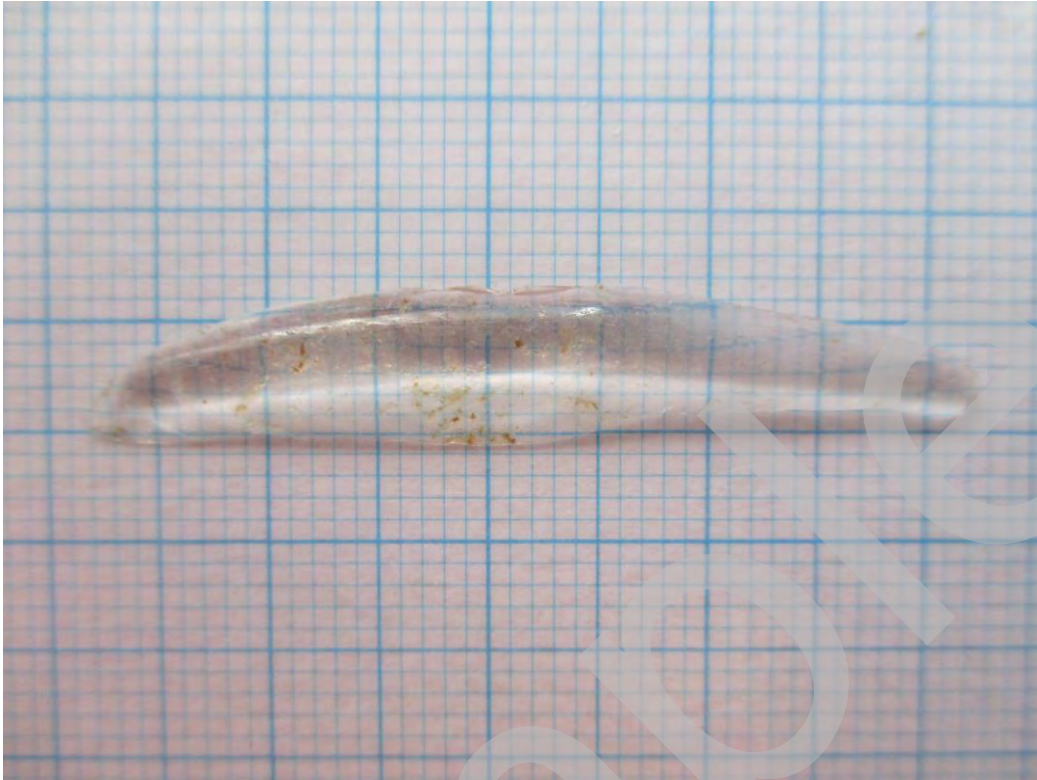
It was concluded that the complaint sample was a worn piece of a rim from a heat-resistant glass, such as 'Pyrex', thought to have originated from an item measuring approximately 12cm in diameter. Potential sources include domestic items, such as bowls and casserole dishes. The stainless steel scuff marks on the apex of the fragment may have originated from contact with a tap/similar item, which may in turn have caused the initial breakage. Alternatively, the scuff marks could have originated from repeated contact with a metal drainage board. The surface deposit adhered to the complaint sample was consistent with contact with the reported product in addition to tomato. The fungal matter seen within the surface deposit was considered to be due to degradation of the surface deposit.

PLATE 1 Shows the complaint sample photographed as received against a millimetre-squared background

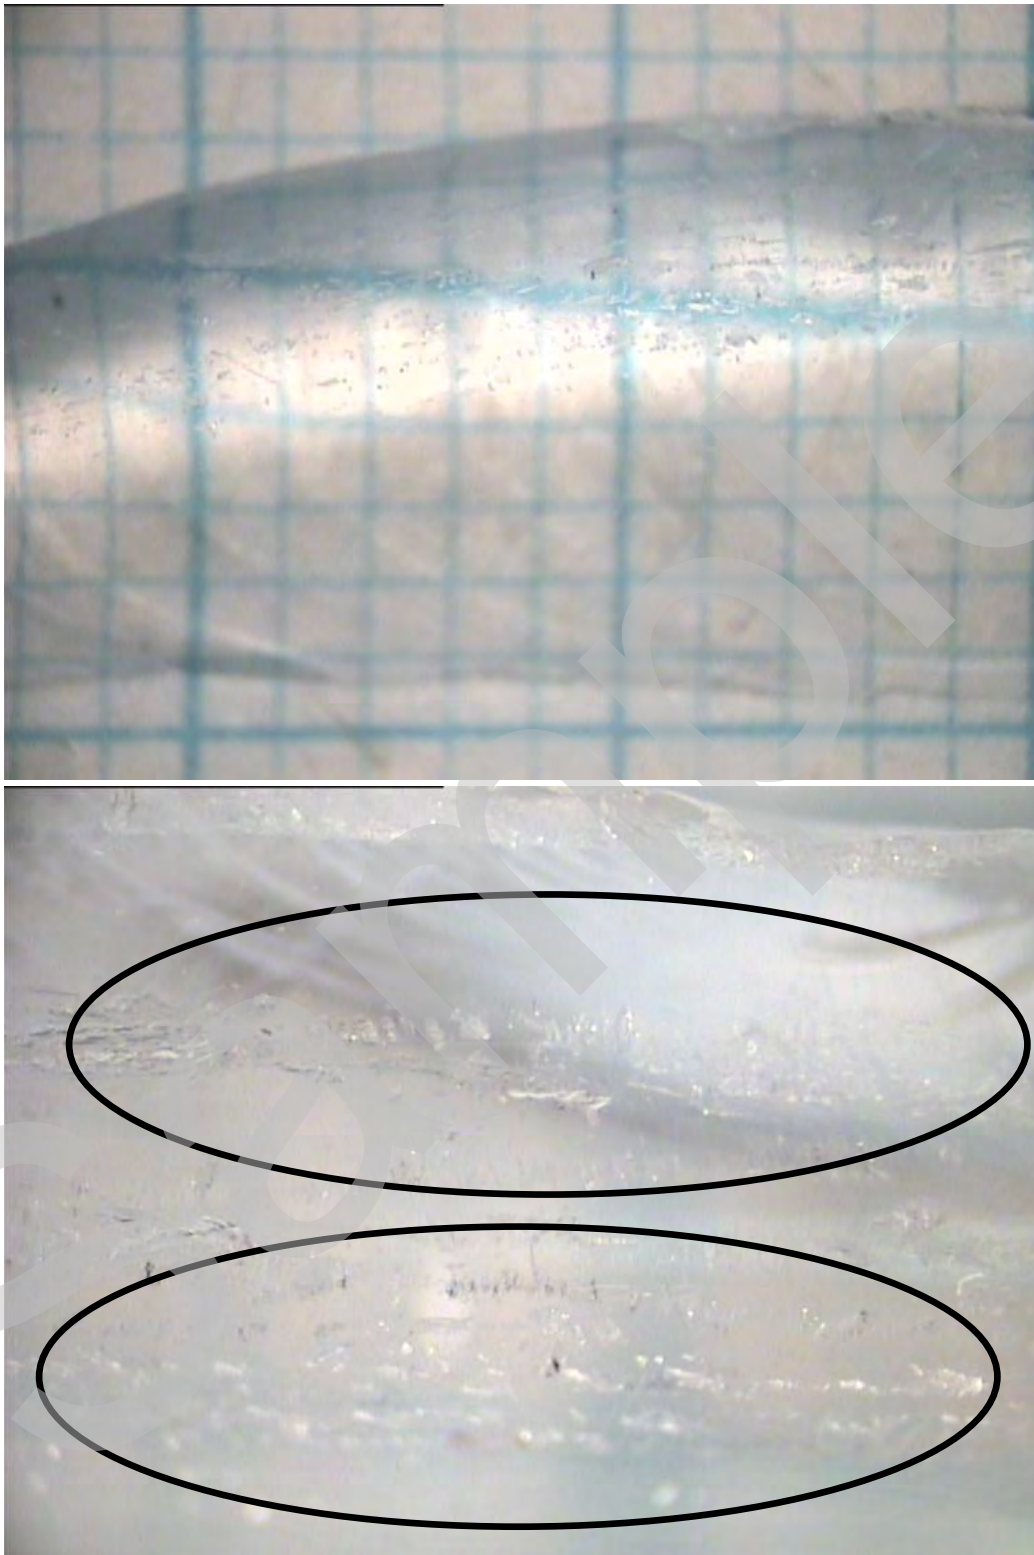
X-ray microanalysis was also performed on the metallic scuff marks (Figure 2). This showed the presence of the above elements, in addition to nickel, chromium, manganese and iron, all of which are constituents of stainless steel. An elemental map showing the distribution of these elements can be referred to in Figure 3.

PLATE 2 Shows an example of the scuff marks (circled) seen along the apex of the fragment (top) and a close up (bottom)

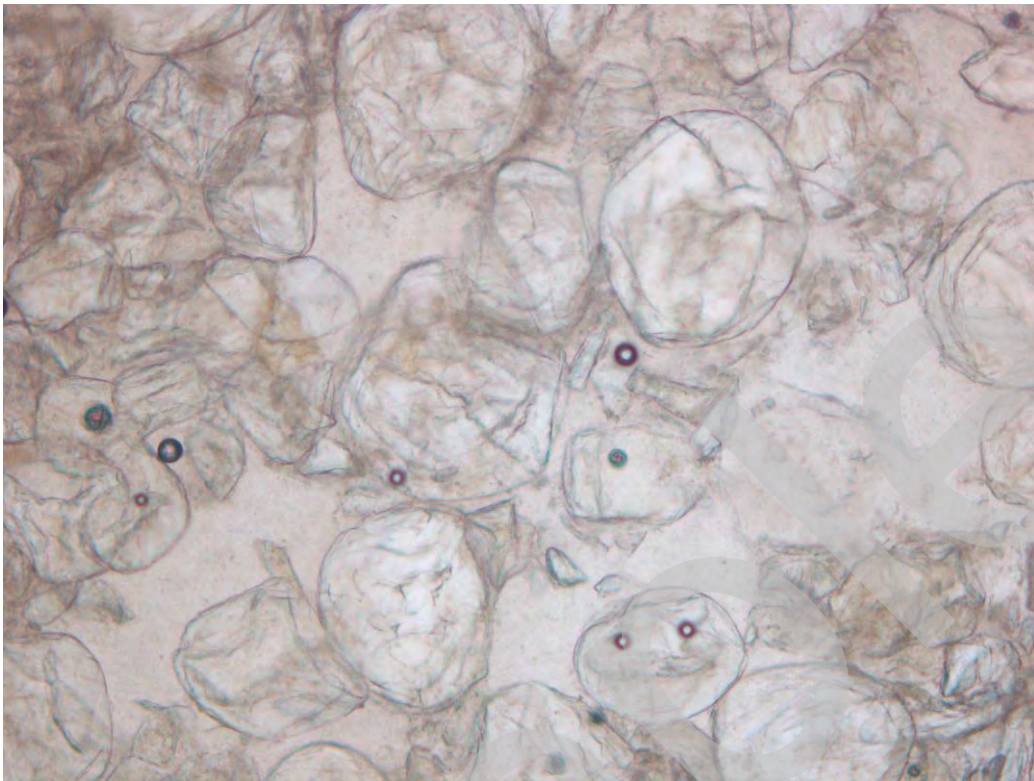
PLATE 3 Shows some of the potato cells seen within the surface deposit adhered to the complaint sample. Magnification x 109

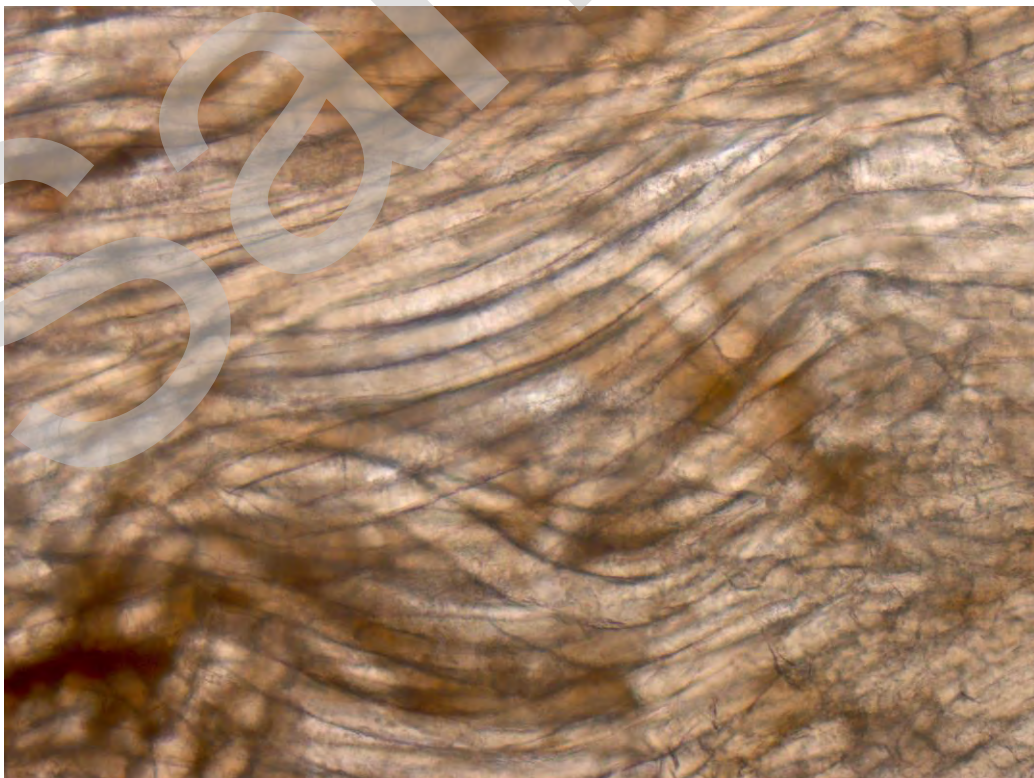
PLATE 4 Shows an example of the muscle fibres seen within the surface deposit adhered to the complaint sample. Magnification x 109

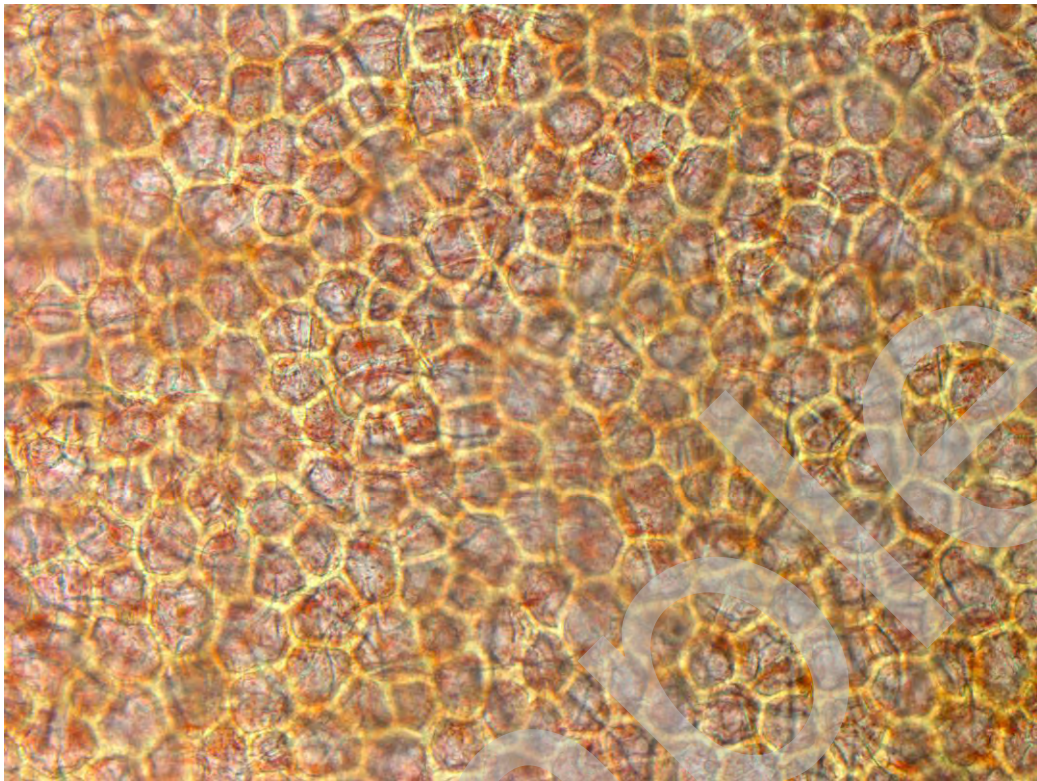
tomato or garden/chilli pepper, cells consistent with the skin of a tomato (Plate 5), 'hook' hairs consistent with a herb (Plate 6), plant leaf tissue possibly from parsley (Plate 7) fat and fungal hyphae (Plate 8).

PLATE 5 Shows the cells consistent with the skin of a tomato, seen within the surface deposit adhered to the complaint sample. Magnification x 220

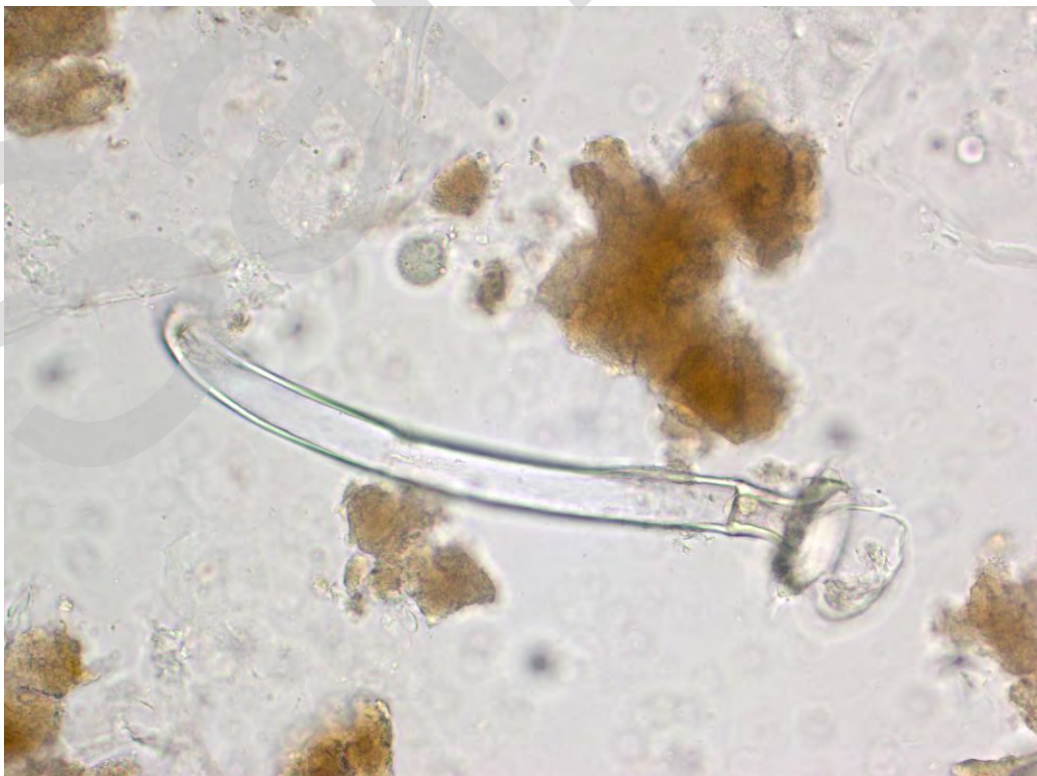
PLATE 6 Shows one of the 'hook' hairs seen within the surface deposit adhered to the complaint sample. Magnification x 435

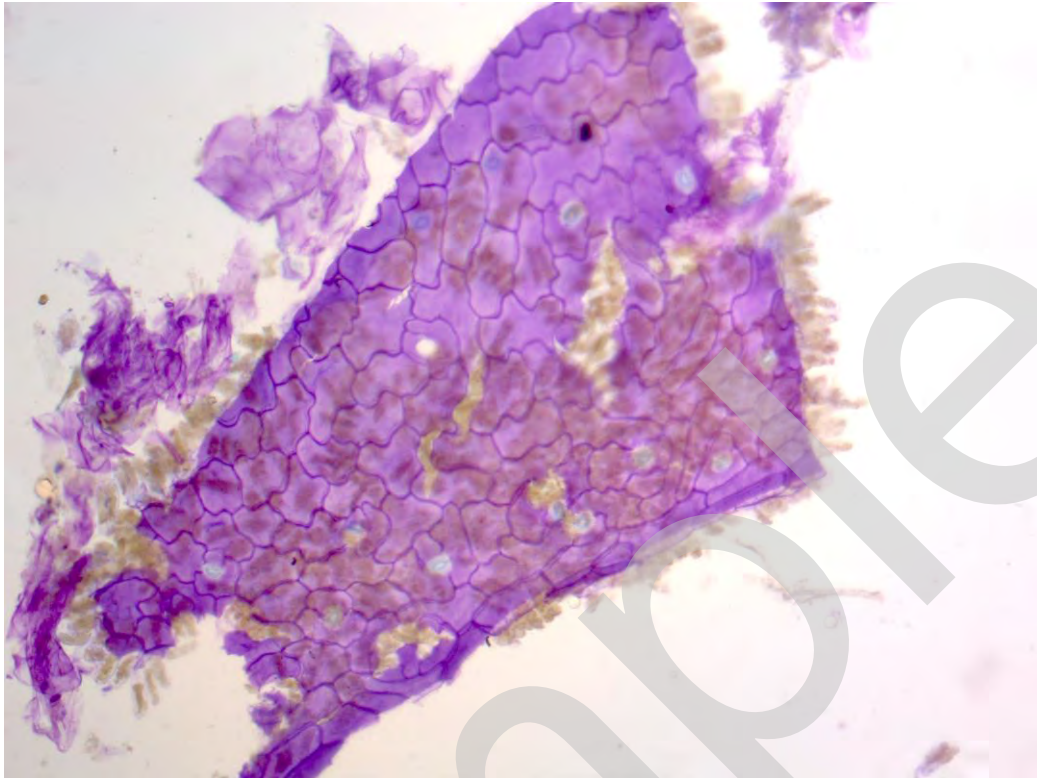
PLATE 7 Shows the cells consistent with parsley, highlighted purple with toluidine blue seen within the surface deposit adhered to the complaint sample. Magnification x220

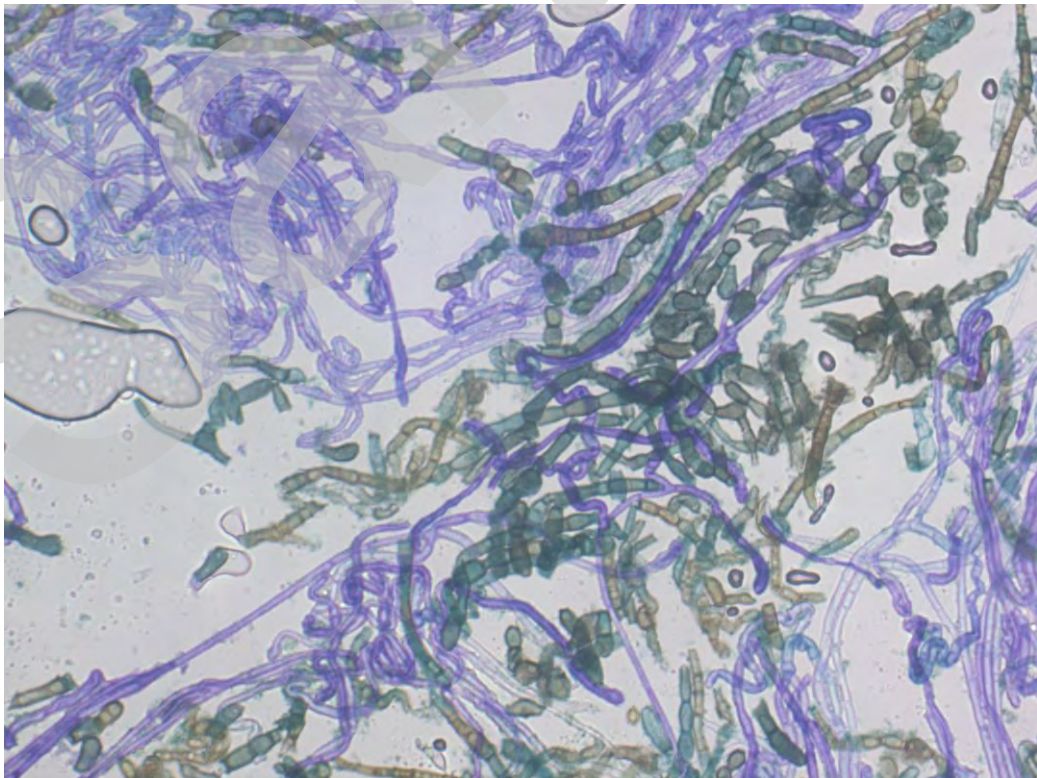
PLATE 8 Shows an example of the fungal hyphae seen within the surface deposit adhered to the complaint sample. Magnification x435

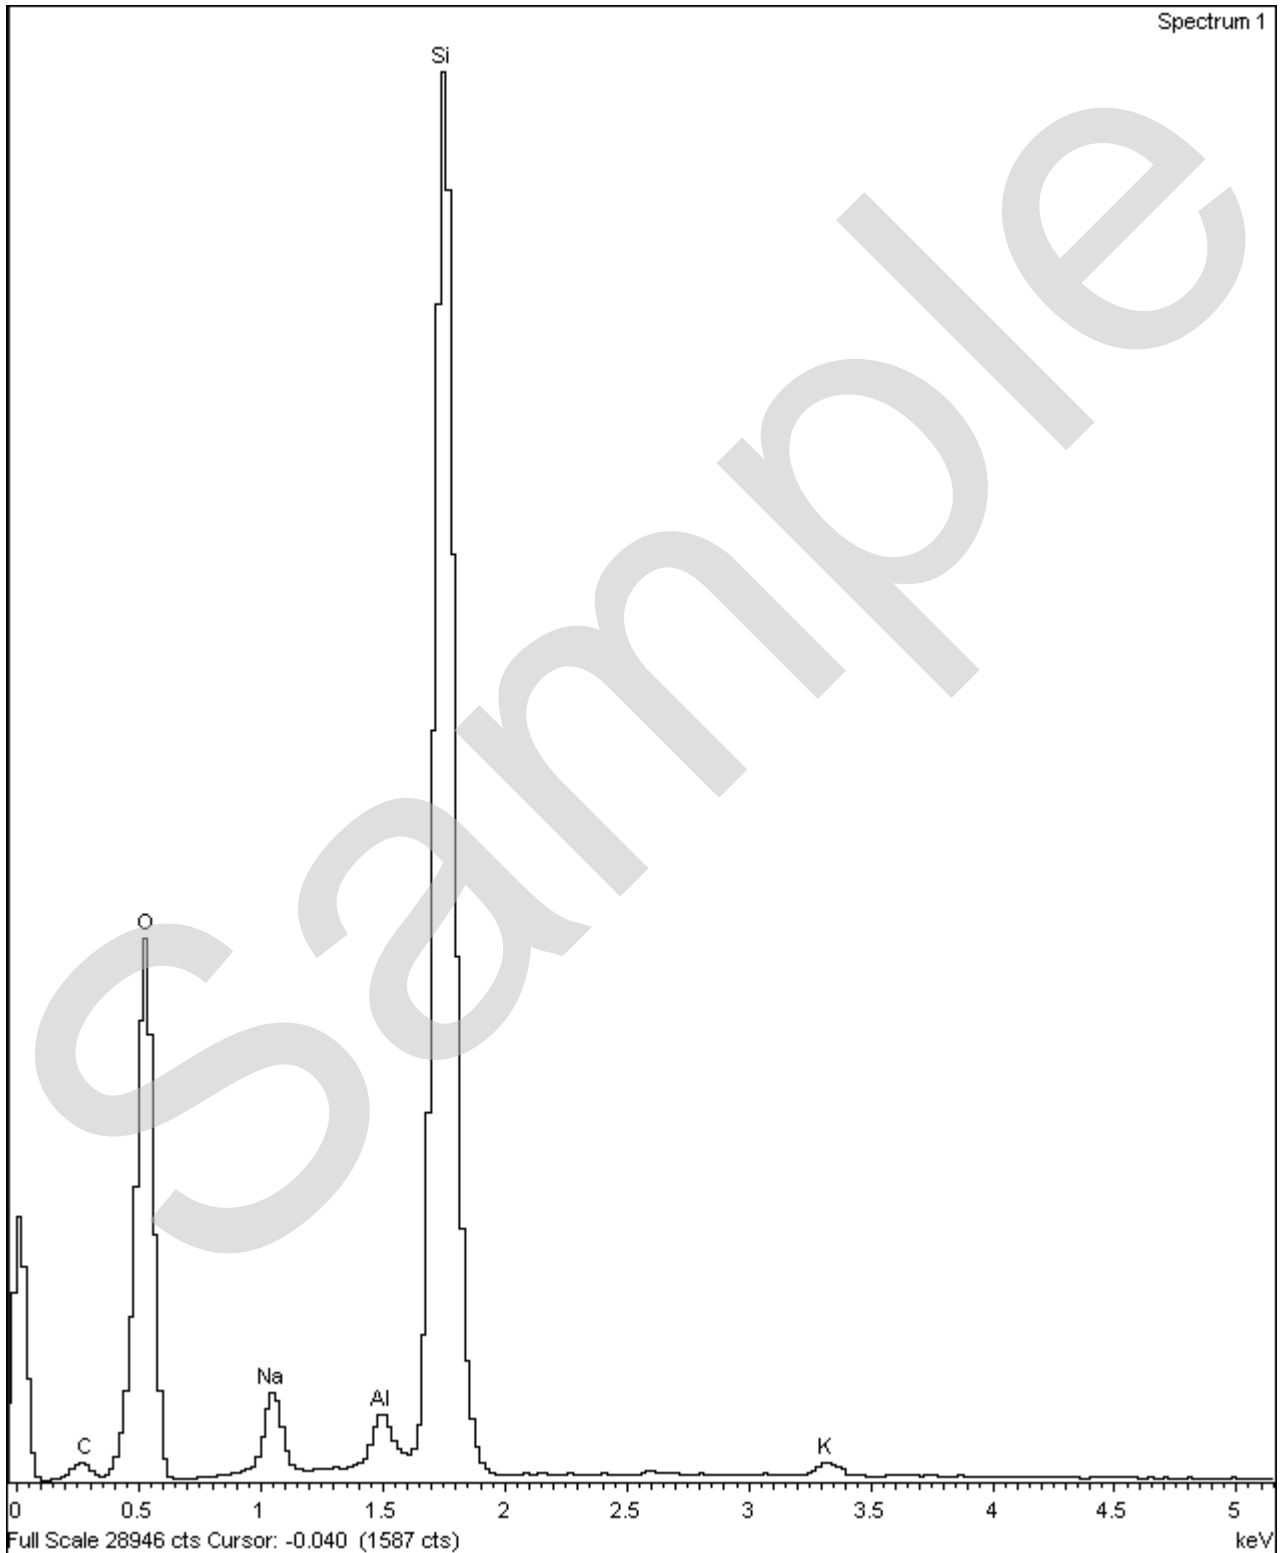
LIMS Project Number: 170532-00526
LIMS Sample Number: 15232565

X-ray microanalysis was performed on the complaint sample (Figure 1). This showed the presence of oxygen, sodium, aluminium, silicon and potassium. This is a typical composition of heat-resistant glass, such as 'Pyrex'.

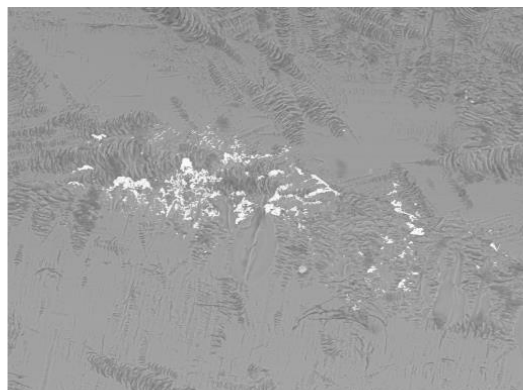
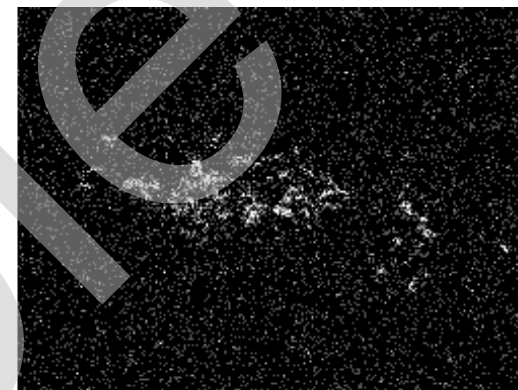
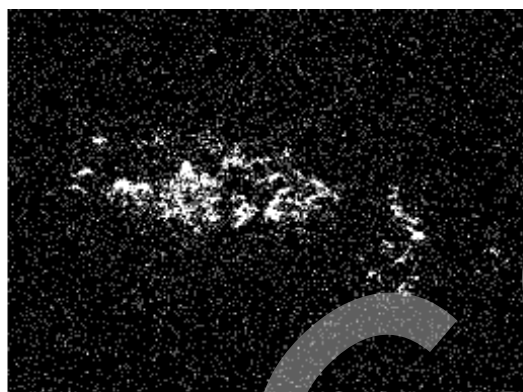
FIGURE 3

The top left image is an electron micrograph of one of the metallic scuff marks, taken using the backscatter detector. The bright white area denotes the presence of elements with a higher atomic number compared to the background material (glass). The remaining images are element maps, showing the distribution of nickel (Ni), chromium (Cr), and iron (Fe) in and around the scuffed area, represented by the white regions.
