Campden BRI

Investigation of Corrosion on External Surface of Cans

Work performed by Campden BRI (Chipping Campden) Limited
Report number: MI/REP/180010-00024/1 ♦ Issue date: 20th April 2018

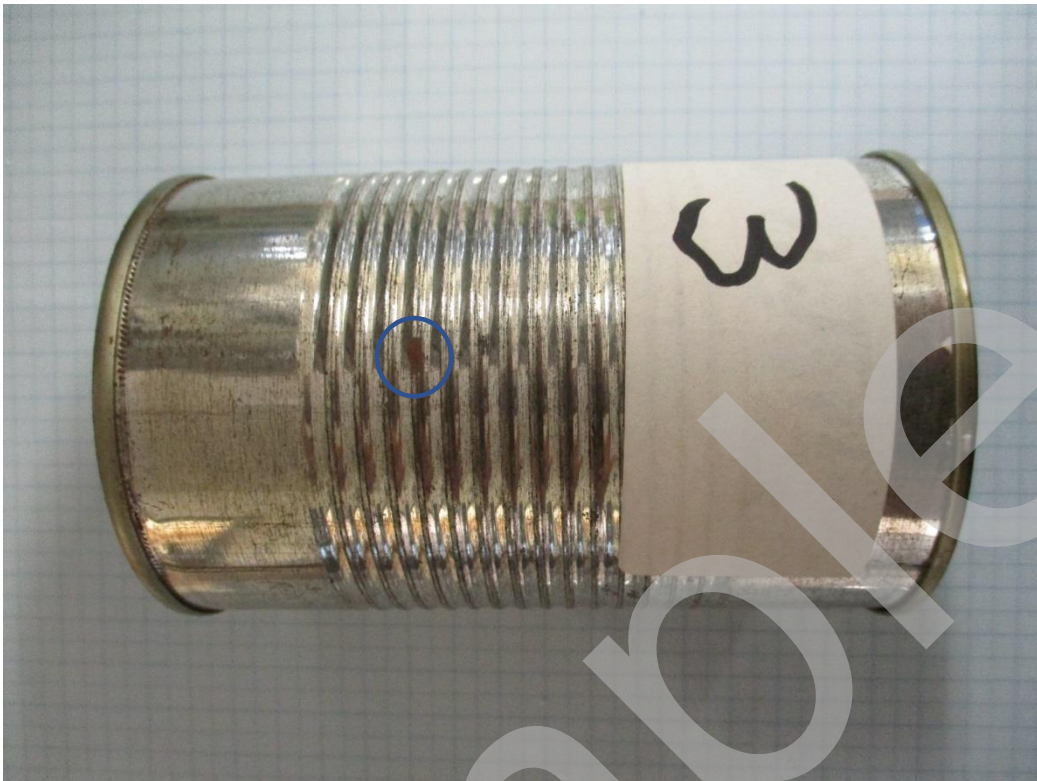
A single, opened, empty can was received by the Microscopy section, for the investigation of external corrosion. The client had stated that the same type of corrosion had been seen in multiple locations on numerous cans. The can was photographed as received and can be referred to in Plate 1.

PLATE 1 Shows the complaint can photographed as received to show the presence of corrosion on the body (circled), against a millimetre-squared background

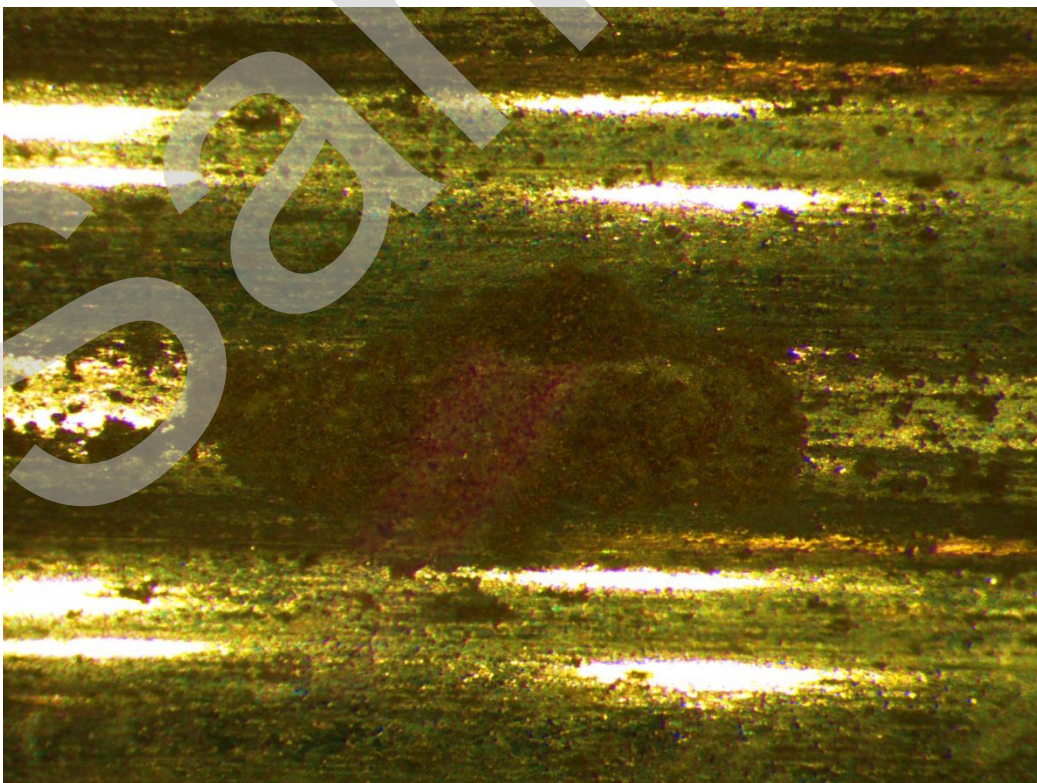
Examination visually and under a stereomicroscope showed that the corrosion was contained to a single area on the body of the can (Plate 2). No hole could be seen in this area and no corrosion was seen internally.

It was concluded that the can submitted for analysis showed corrosion in one area on the body of the can, the corrosion was restricted to the surface only and no hole or internal corrosion was seen. Elemental analysis showed the presence of chlorine in the corroded area, chlorine residues from water treatment left on the surface of a can, followed by insufficient drying techniques can lead to corrosion. Due to the level of chlorine exhibited in the corroded area this was thought to be the cause of the corrosion.

PLATE 2 Shows a close up of the area showing corrosion viewed under stereo-microscope. (Note the gold colour effect to the can is an artefact of light)

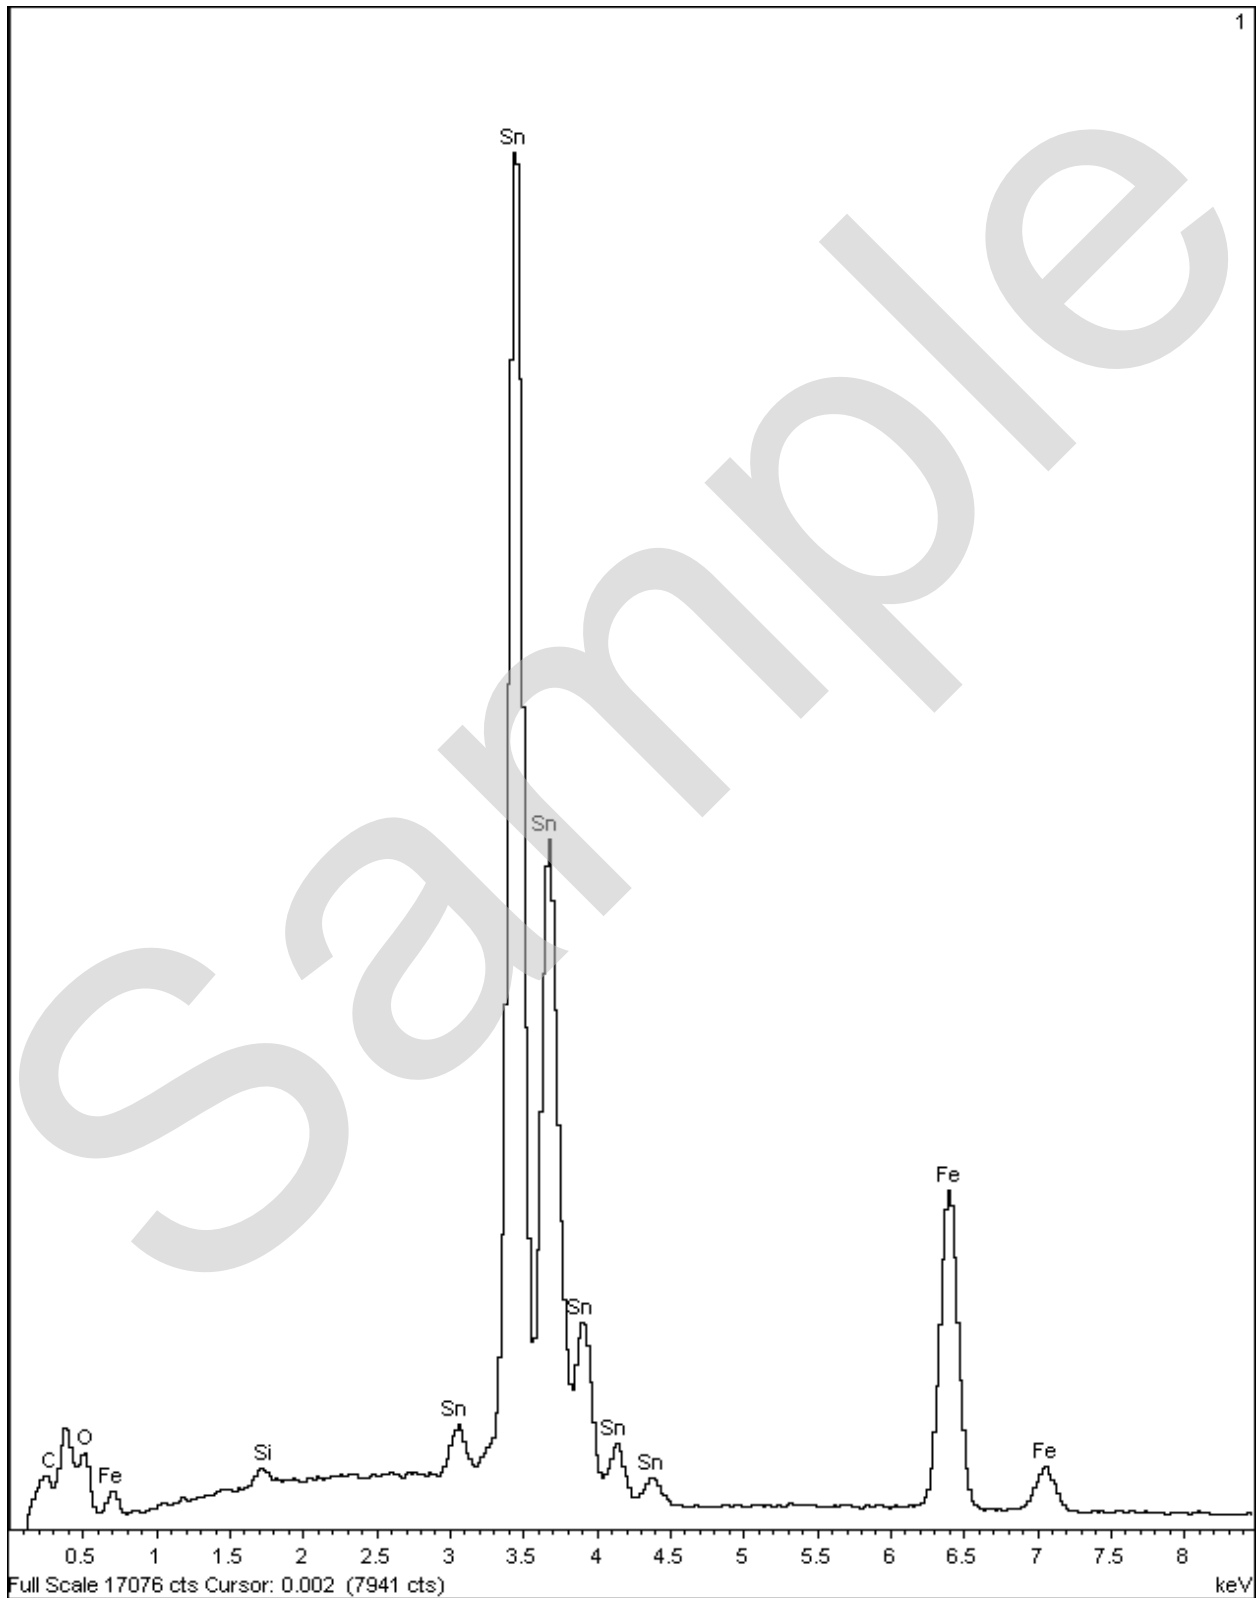
A reference area and the area showing the corrosion were examined using x-ray microanalysis. The reference area showed the presence of carbon, oxygen, iron, silicon and high peaks of tin (Figure 1). The area showing corrosion showed the presence of carbon, high peaks of oxygen, higher peaks of iron, silicon, chlorine and reduced peaks of tin; trace amounts of sodium, magnesium, aluminium, phosphorus and sulphur were also seen (Figure 2). Together these spectra confirm the absence of a tin coating and exposure of steel in the corroded area. The corroded area also showed the presence of chlorine, which is commonly found in cooling water.

LIMS Project Number : 180423-00919
Reference area of the complaint can
